# Skaneateles Lake Water Service Illustration

## WATER SAMPLE TEST RESULTS, 2018

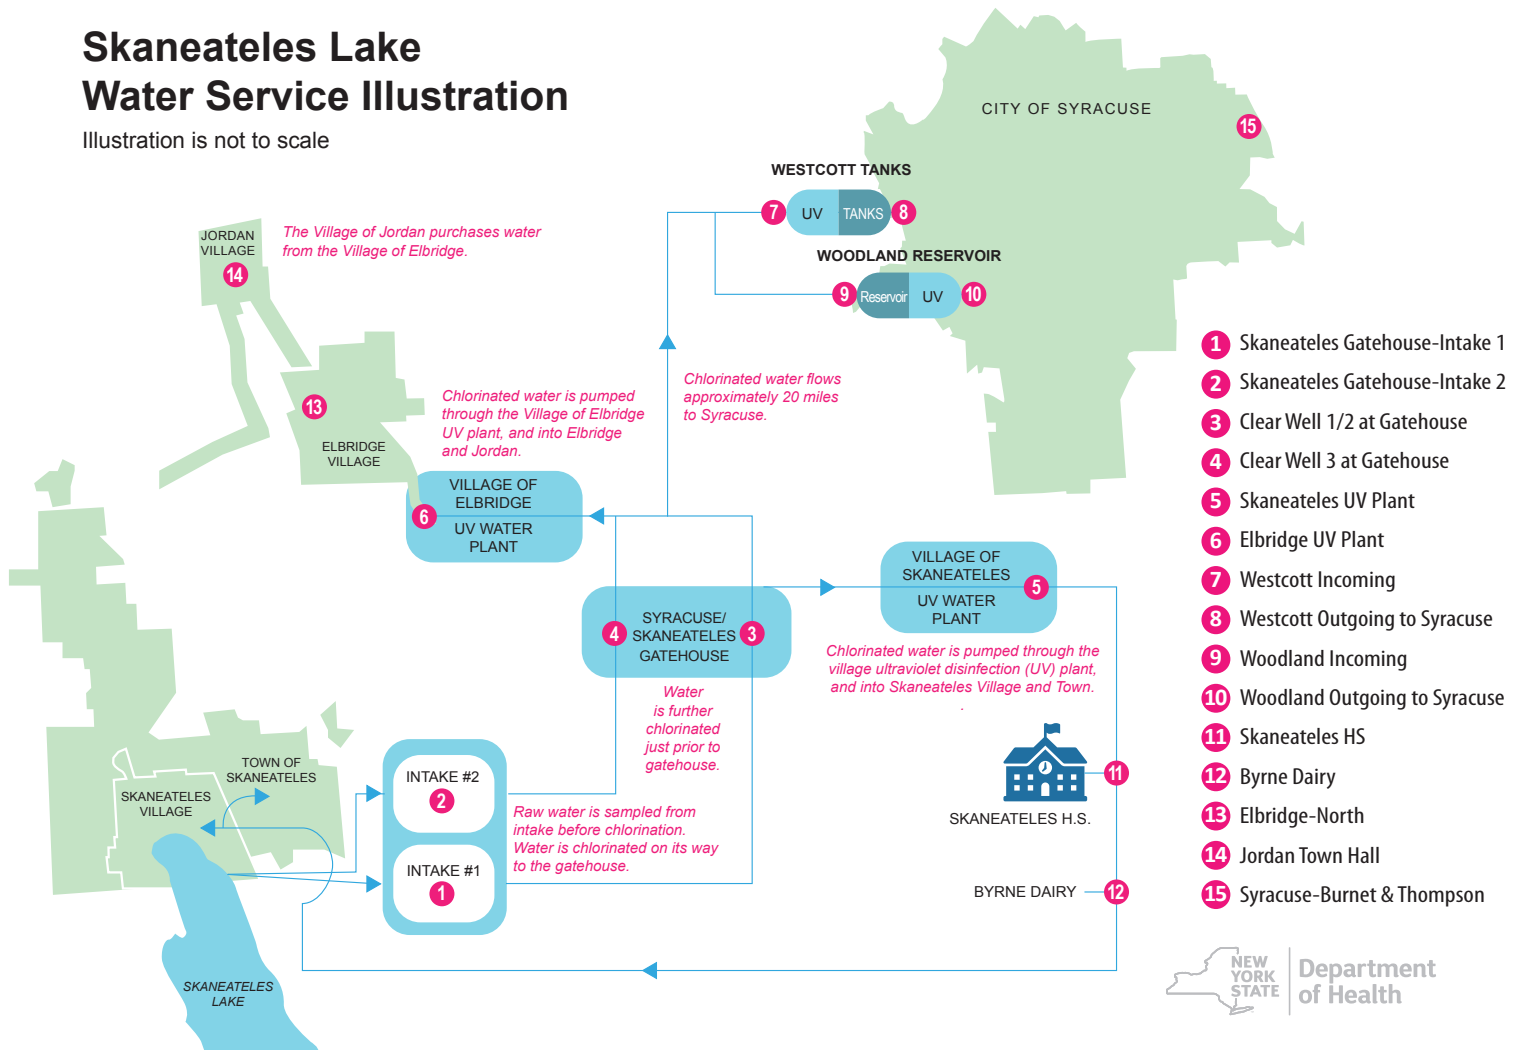
Illustration is not to scale

7-5	7-12	7-19	7-26	8-2	8-4	8-6	8-7	8-8	8-9	8-10
<b>1</b> Skaneateles Gatehouse-Intake 1	*	*	*	*	*	*	*	*	*	ND	*
<b>2</b> Skaneateles Gatehouse-Intake 2	ND	ND	ND	ND	ND	ND	.33	.3	ND	ND	ND
<b>3</b> Clear Well 1/2 at Gatehouse	-	-	-	-	-	-	-	-	-	ND	-
<b>4</b> Clear Well 3 at Gatehouse	-	-	-	-	-	-	ND	ND	ND	ND	ND
<b>5</b> Skaneateles UV Plant	-	-	-	-	-	-	-	-	-	-	-
<b>6</b> Elbridge UV Plant	-	-	-	-	-	-	-	-	-	-	-
<b>7</b> Westcott Incoming	-	-	-	-	-	-	-	-	-	-	-
<b>8</b> Westcott Outgoing to Syracuse	-	-	-	-	-	-	-	-	-	-	-
<b>9</b> Woodland Incoming	-	-	-	-	-	-	-	-	-	-	-
<b>10</b> Woodland Outgoing to Syracuse	-	-	-	-	-	-	-	-	-	-	-
<b>11</b> Skaneateles HS	-	-	-	-	-	-	-	-	-	-	-
<b>12</b> Byrne Dairy	-	-	-	-	-	-	-	-	-	-	-
<b>13</b> Elbridge-North	-	-	-	-	-	-	-	-	-	-	-
<b>14</b> Jordan Town Hall	-	-	-	-	-	-	-	-	-	-	-
<b>15</b> Syracuse-Burnet & Thompson	-	-	-	-	-	-	-	-	-	-	-
