Skaneateles Lake Water Service Illustration

WATER SAMPLE TEST RESULTS, 2021

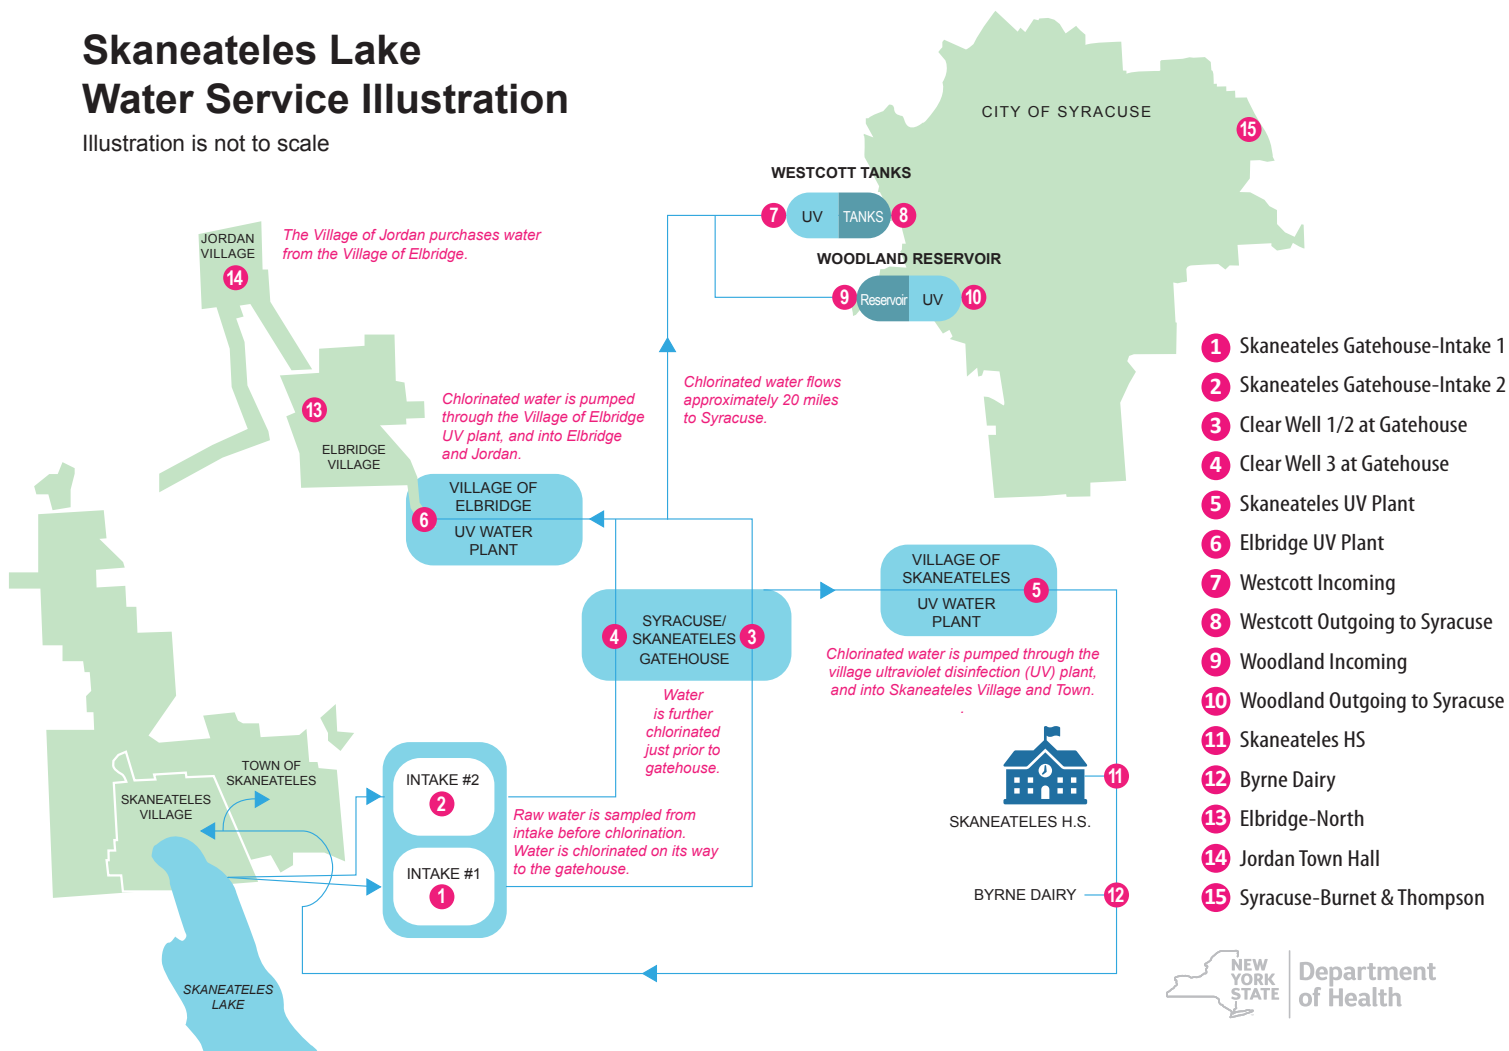
Illustration is not to scale
