5.4.4 GROUND FAILURE

This section provides a profile and vulnerability assessment for the ground failure hazard.

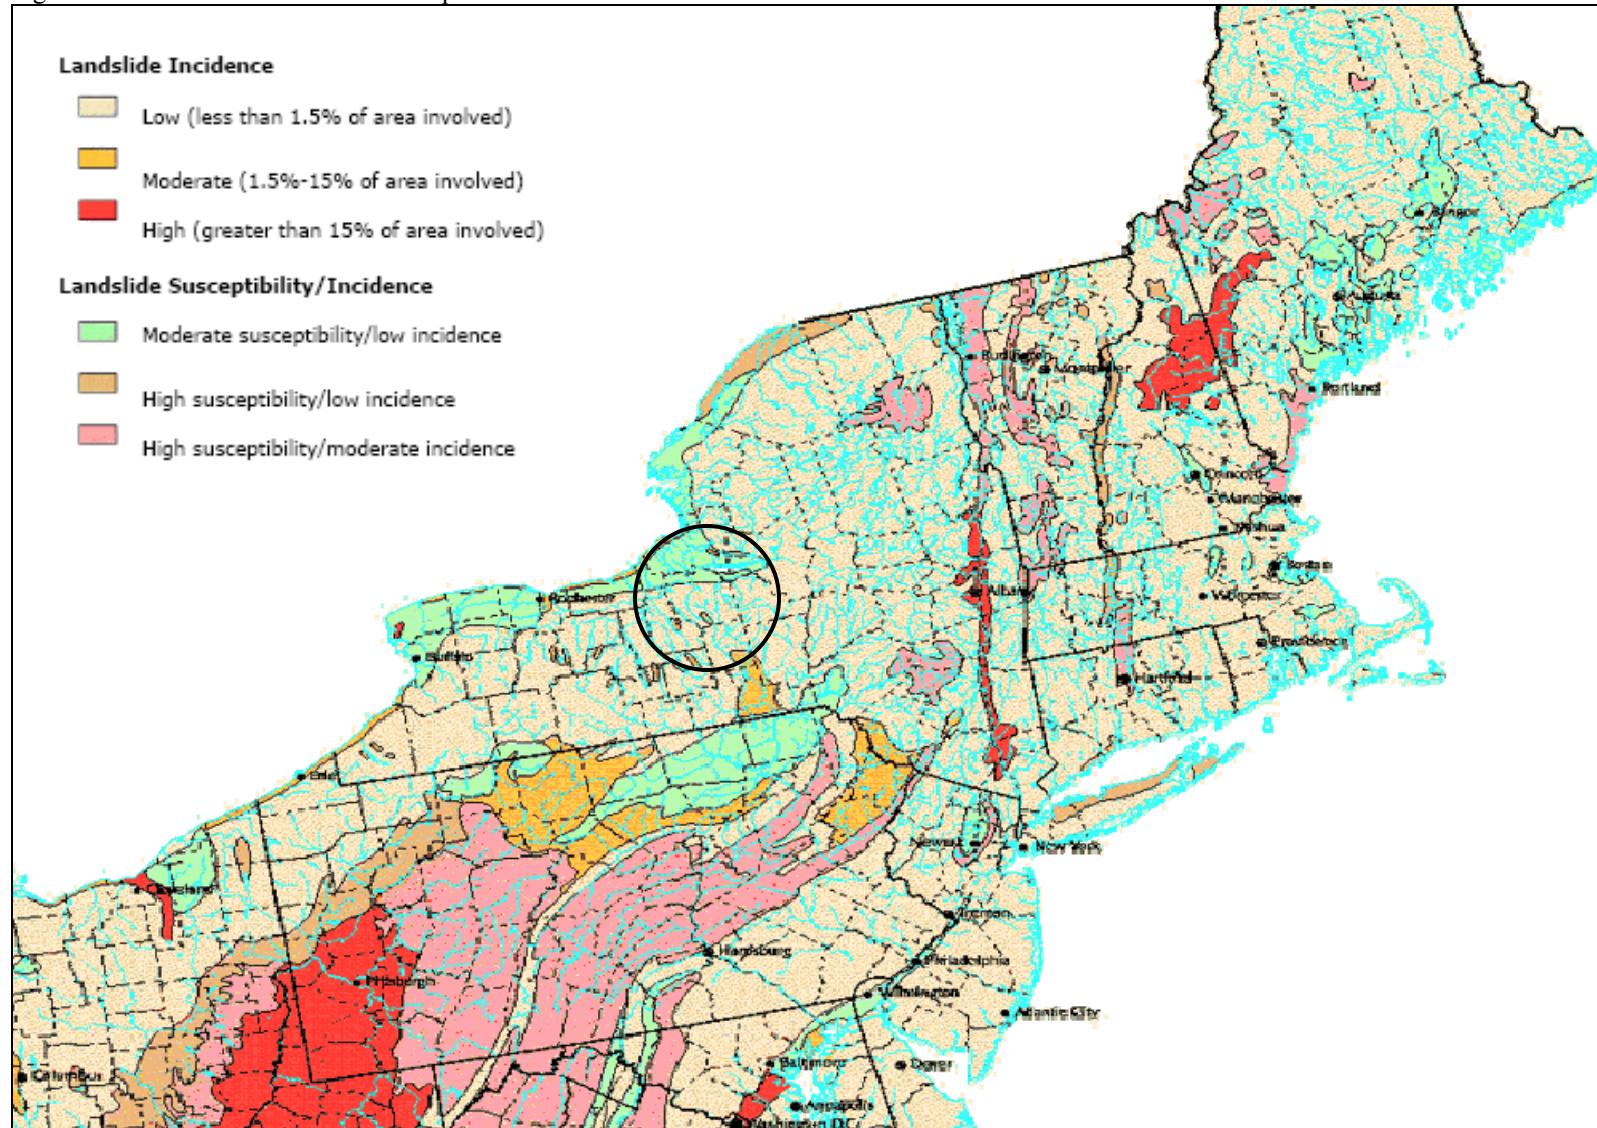
Figure 5.4.4-1. Landslide Overview Map of the Northeast U.S.

Note: Circle indicates the approximate location of Onondaga County.

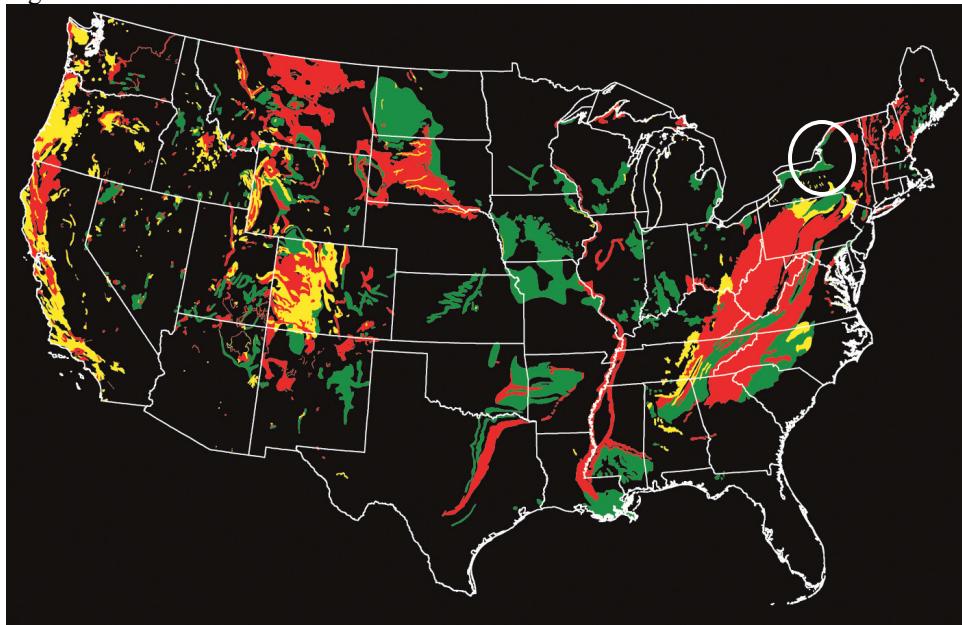
Figure 5.4.4-2. Landslide Potential of the Conterminous U.S. United States

Note: Red areas have very high potential, yellow areas have high potential, and green areas have moderate potential. Landslides can and do occur in the black areas, but the potential is low. Map not to scale. Circle indicates the approximate location of Onondaga County.

The entire U.S. experiences landslides and other ground failure hazards, with 36 states having moderate to highly severe landslide hazards (Figure 5.4.4-2).

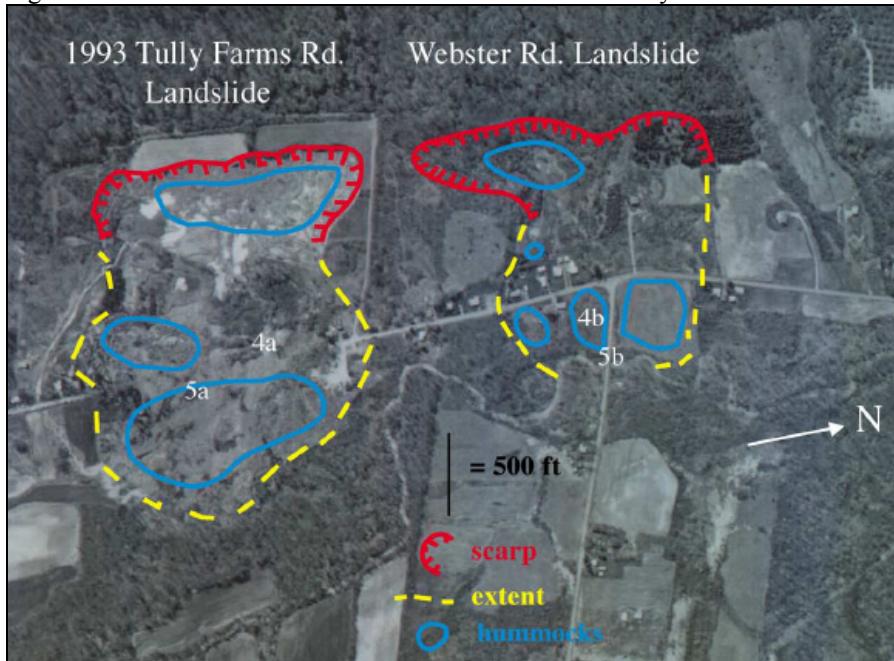
Figure 5.4.4-12. Aerial View of Webster Road and 1993 Tully Farms Road Landslides

Note: Aerial view of the 1993 Tully Farms Road landslide taken May 1, 1993, 4 days after the slide occurred, and approximate location of Webster Road landslide to the north. Dashed lines indicate probable extent of the Webster Road landslide beyond Onondaga Creek. Numbers reference figures located in the Pair / Kappel report.

The age of the Webster Road Landslide was estimated from radiocarbon dating of peat-like organic and woody material found directly beneath mudflow deposits at several locations within the toe of the Webster Road landslide. Radiocarbon ages on these organics indicate that the land surface and associated vegetation were buried by a mudflow approximately 6,100 years ago (Pair and Kappel, 2001). This landslide is further depicted in Figure 5.4.4-12 under the 1993 Tully Farms Road description.

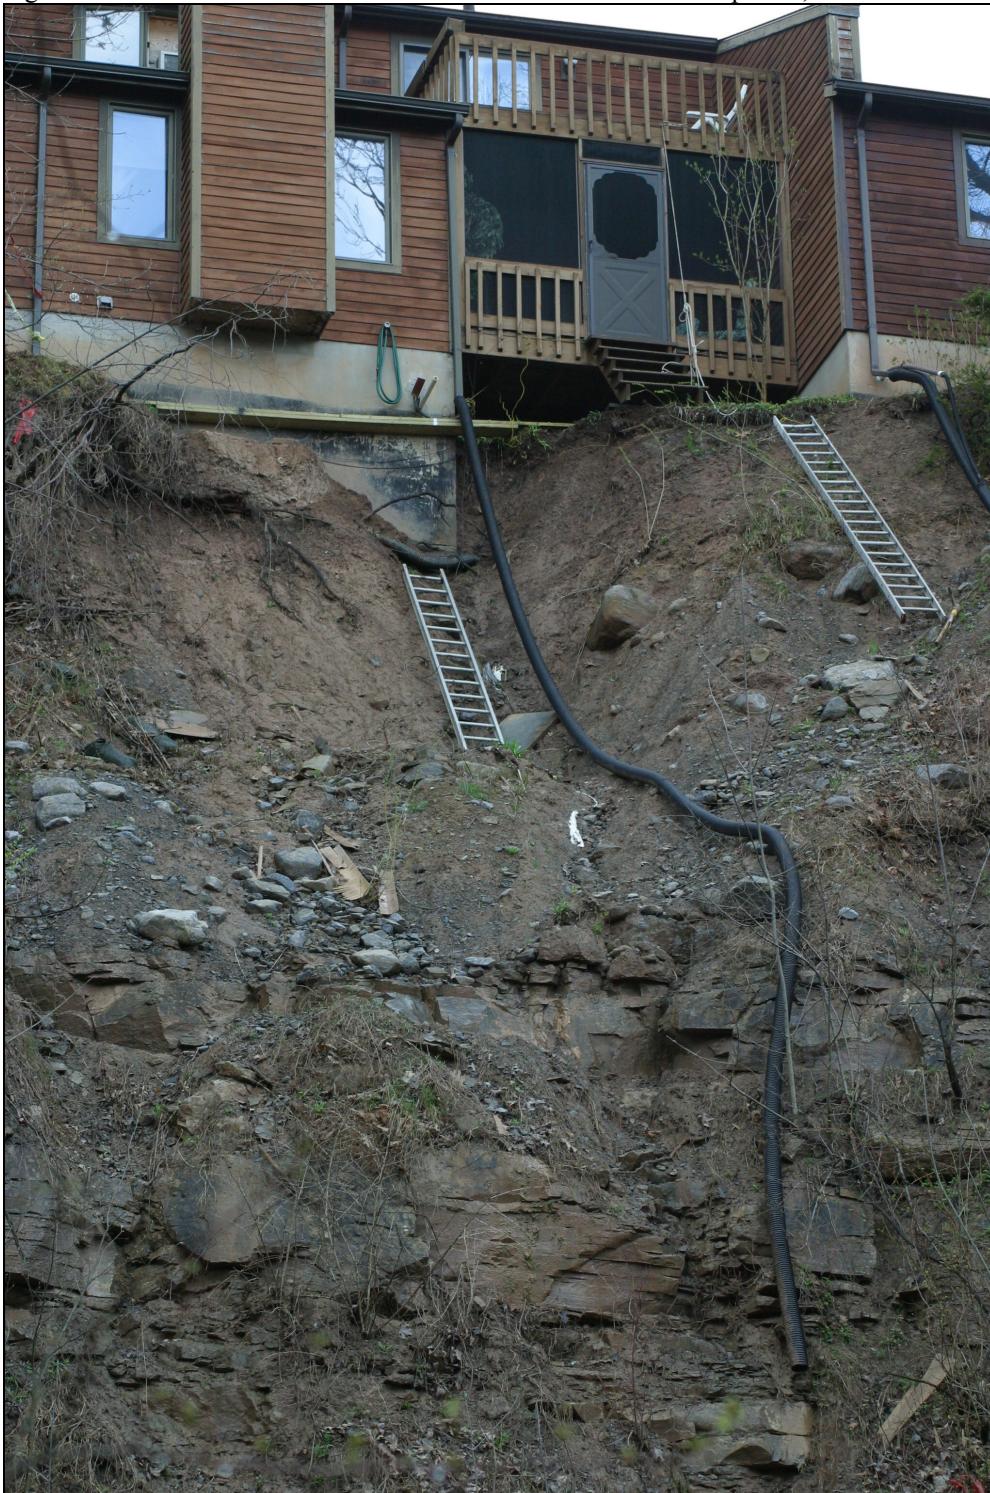
Figure 5.4.4-16. The Rear of 8181 Bluffview Drive in Manlius on April 30, 2007

Notes: This photograph was taken prior to a jute mat placed on the soil behind this unit to mitigate the eroding soil.

home. They have tried to mitigate the ground failure behind their home and have incurred tremendous costs in doing so (over \$100K) (Novek, 2009). Figures 5.4.4-15 and 5.4.4-16 illustrate the slope behind 8181 Bluffview.

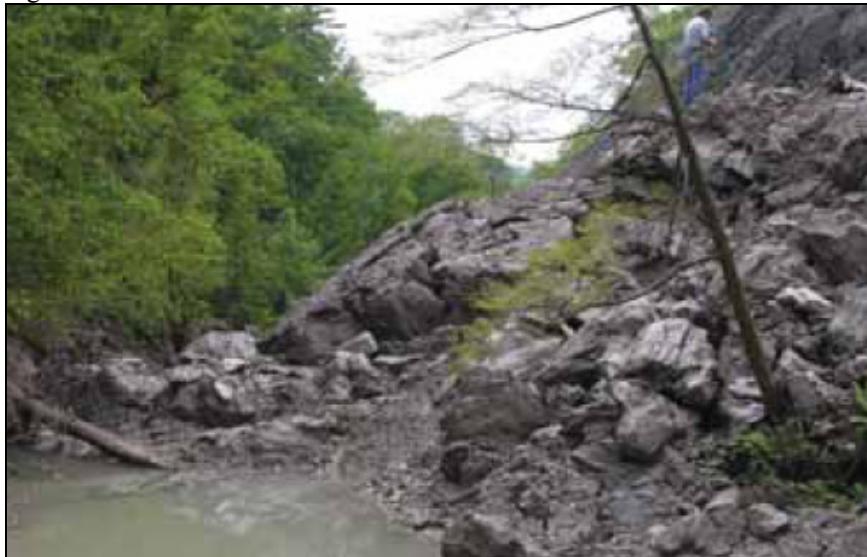
Figure 5.4.4-17. Rattlesnake Gulf Landslide

Rattlesnake Gulf usually flows turbid each spring due to small slope failures. Review of aerial photography for the last 30 years indicates that this area has slowly been failing, probably due to a number of springs which saturate the hillside, but the spring runoff in 2005 probably caused the massive failure (The Upstate Freshwater Institute, 2008).

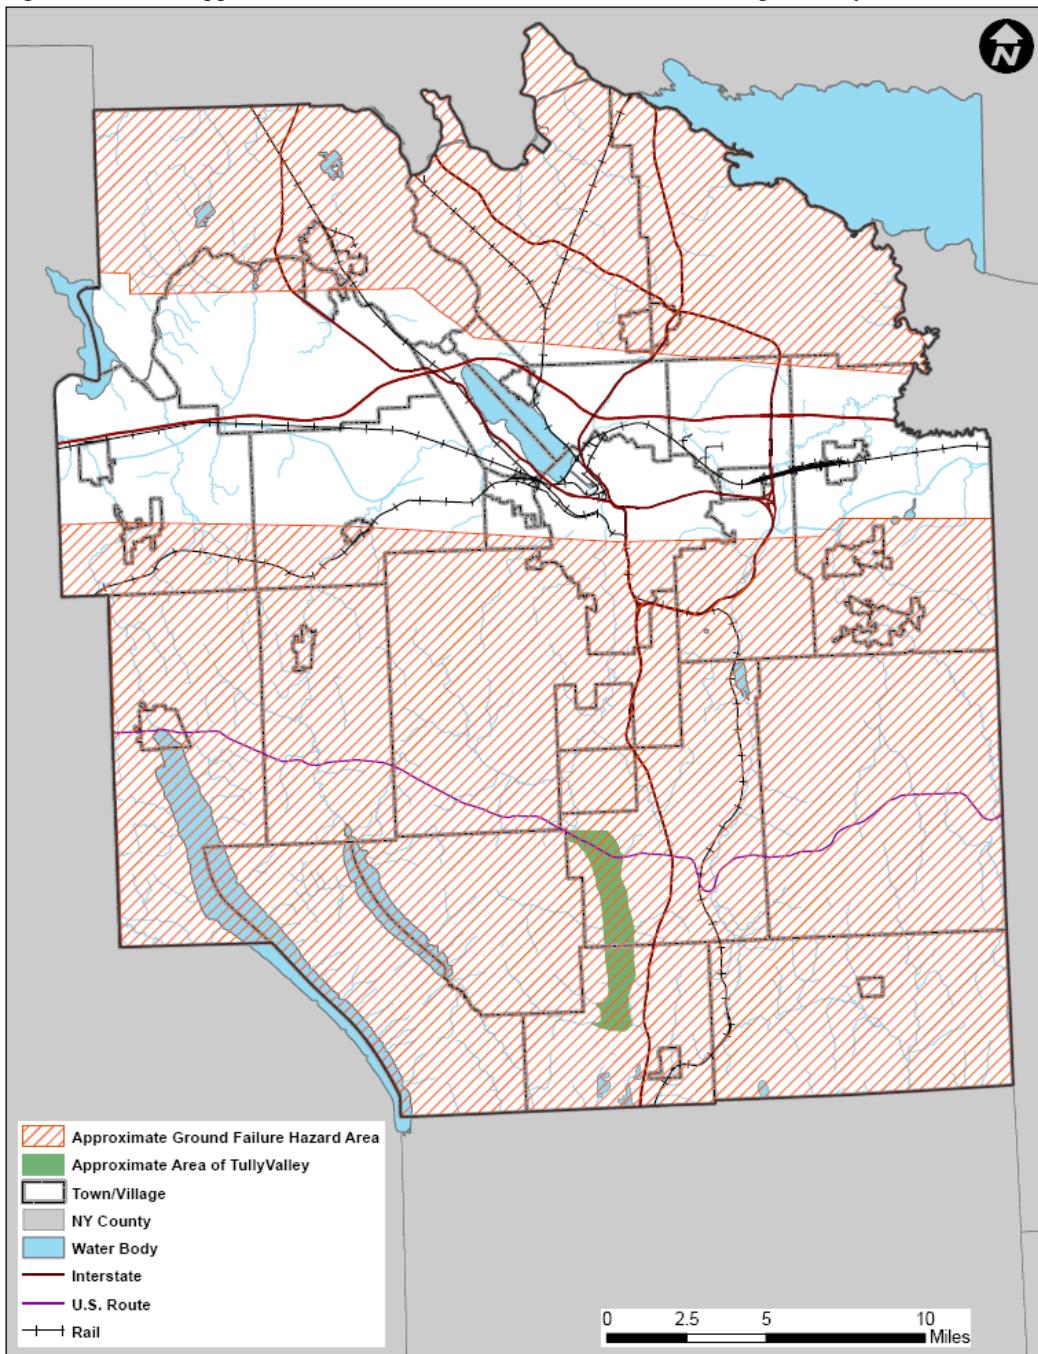
Figure 5.4.4-18. Approximate Ground Failure Hazard Area in Onondaga County

Source: Approximate ground failure hazard area and approximate area of Tully Valley were generated using maps from the following sources: Kappel et al., 2009; NYSDPC, 2008; Pair et al., 2000
